Report on the investigation of
the ejection of six people
from the rigid inflatable boat
Milly

Camel Estuary, Cornwall

on 5 May 2013

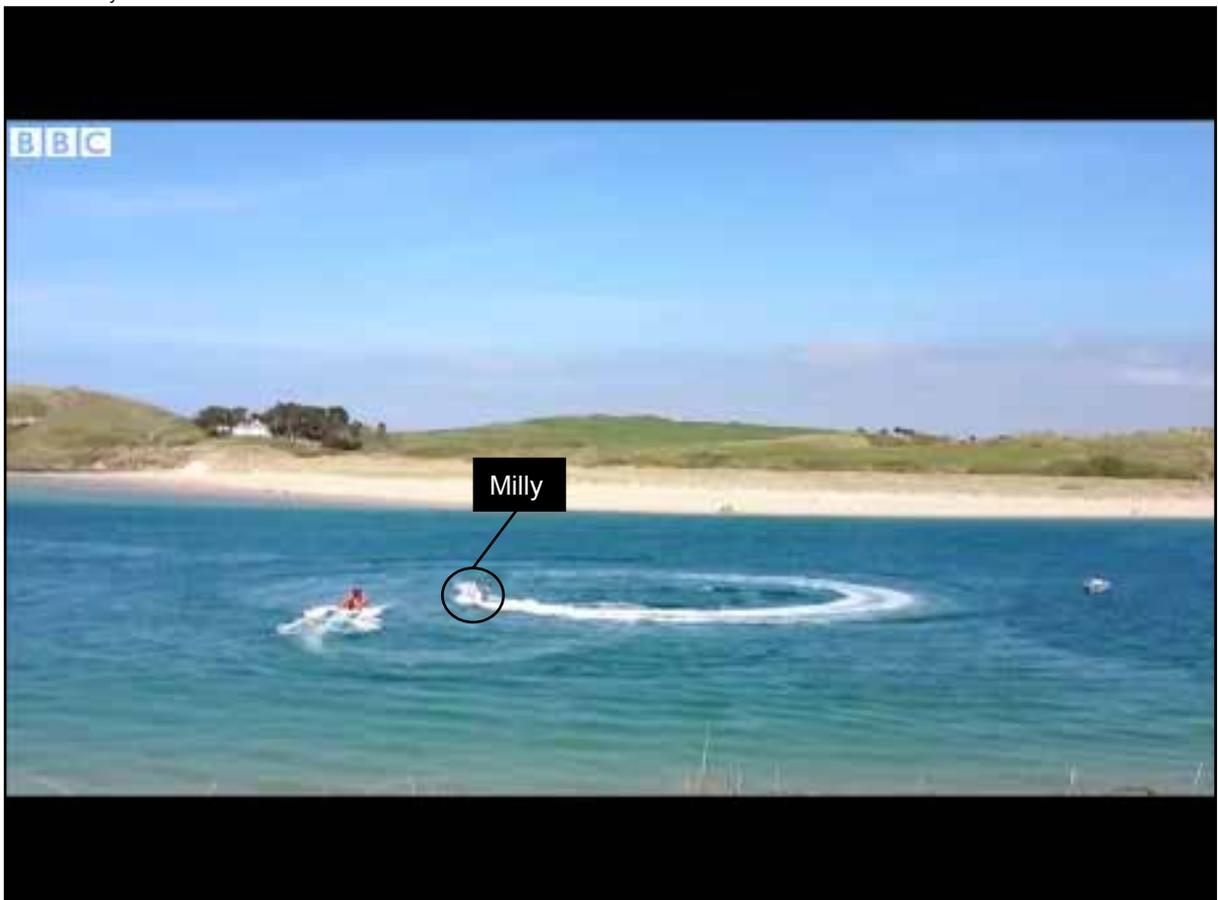
Figure 4: Milly circling out of control after the accident

The single canoeist, who was a local surf lifeguard instructor, initially attempted to intercept *Milly*, which was still circling in the vicinity (**Figure 4**), and at one point his canoe came into contact with the out of control boat. However, once he realised that the boat posed no further threat to the people in the water he went to assist the casualties.

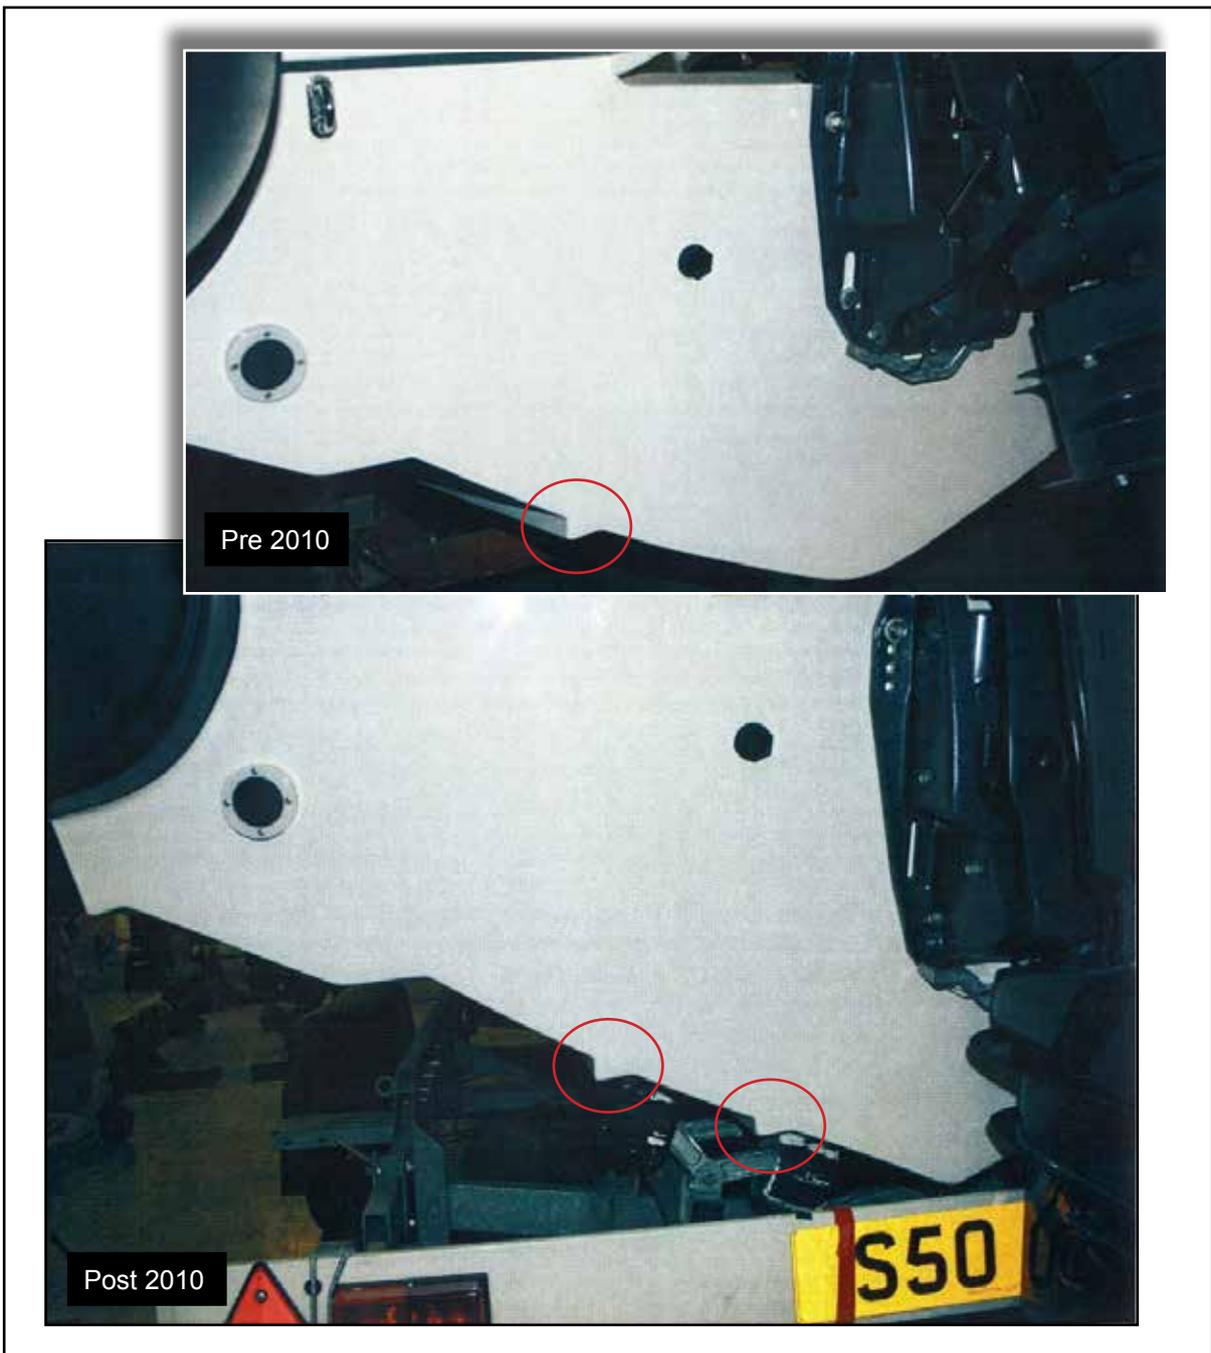
Figure 7: Hull design changes made to Cobra RIBs by manufacturer in 2010

The author of the article, who had previous experience of driving Cobra RIBs, observed that the buoyancy tubes had been raised significantly at the aft end compared with earlier versions of the boat. The report stated that:

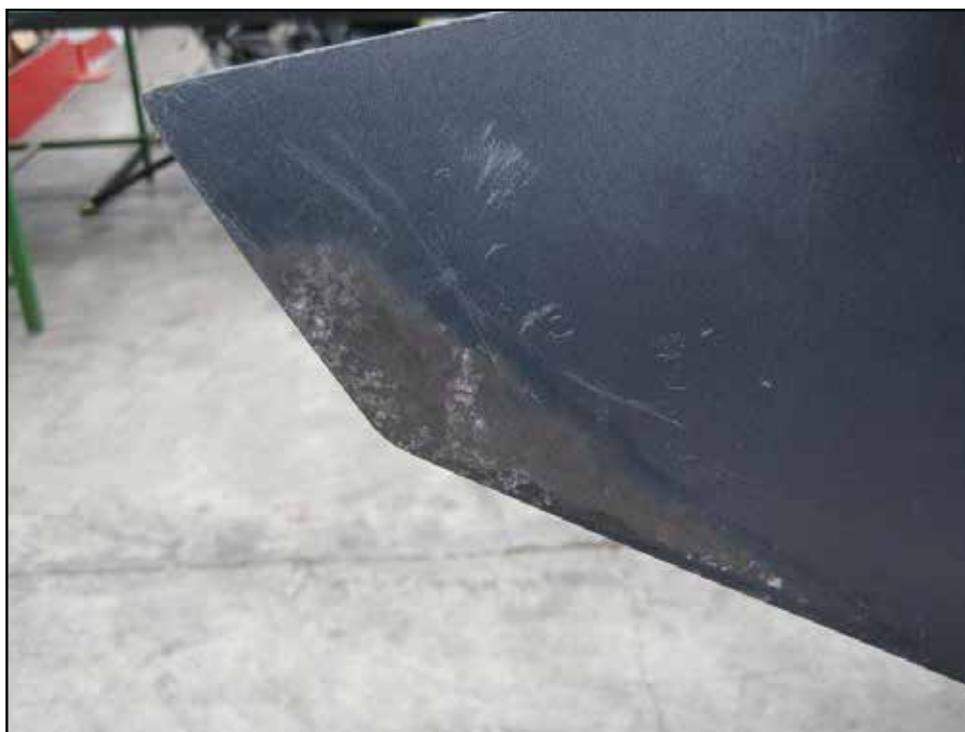
Figure 8: *Milly* - abrasion mark found on engine skeg post-accident

No evidence of damage was found on the hull or engine with the exception of a small, oxidised, abrasion mark on the engine skeg (**Figure 8**).

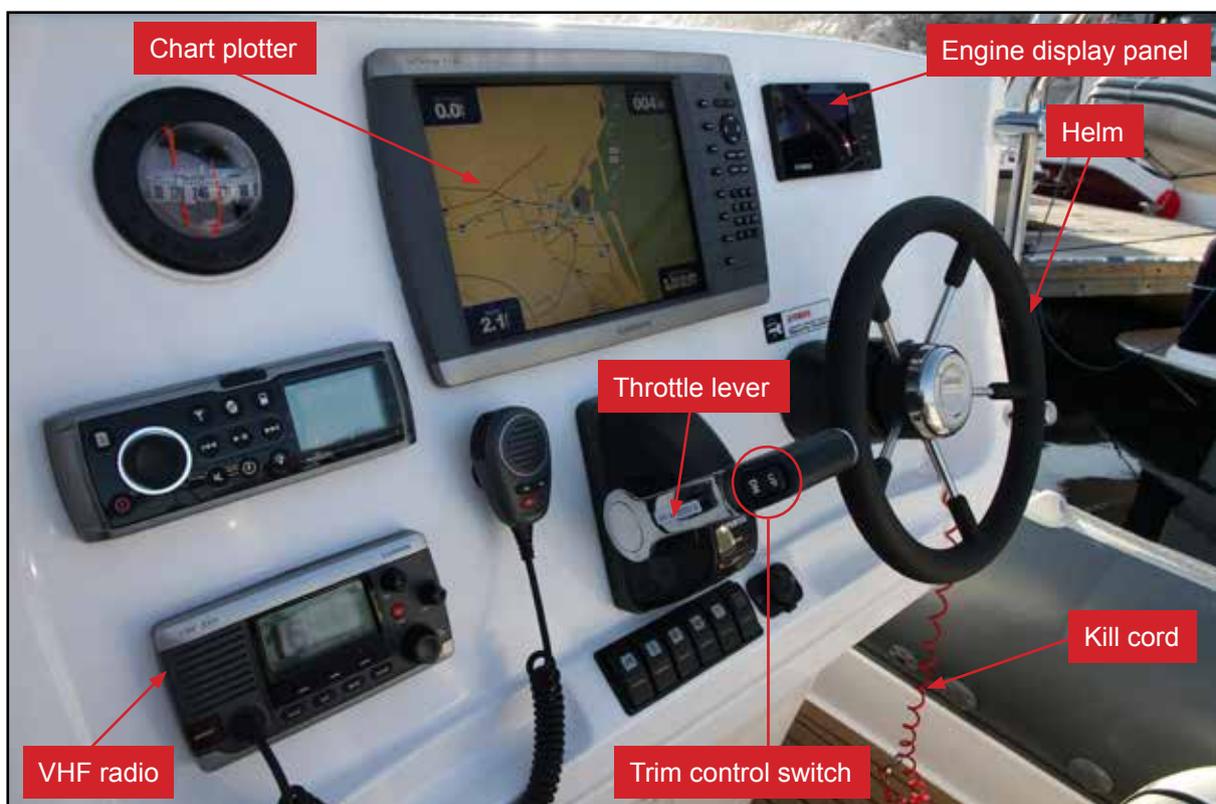
Figure 9: Milly - steering console

The trim settings were displayed on the engine console panel and controlled by the trim adjustment switch located on the throttle handle (**Figure 9**). The trim setting of the engine at the time of the accident was known from evidence obtained to have been in the region of 10-12.

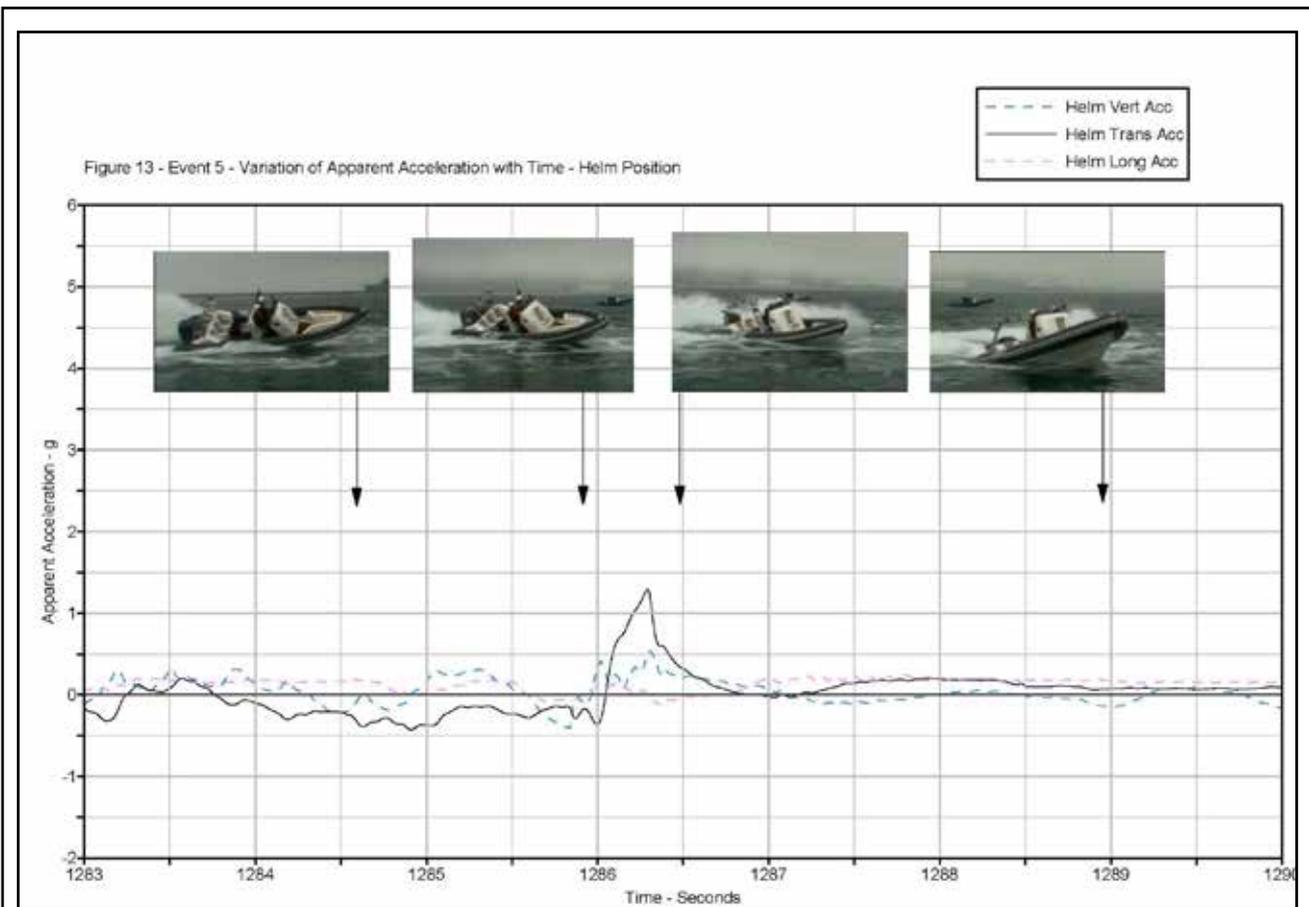
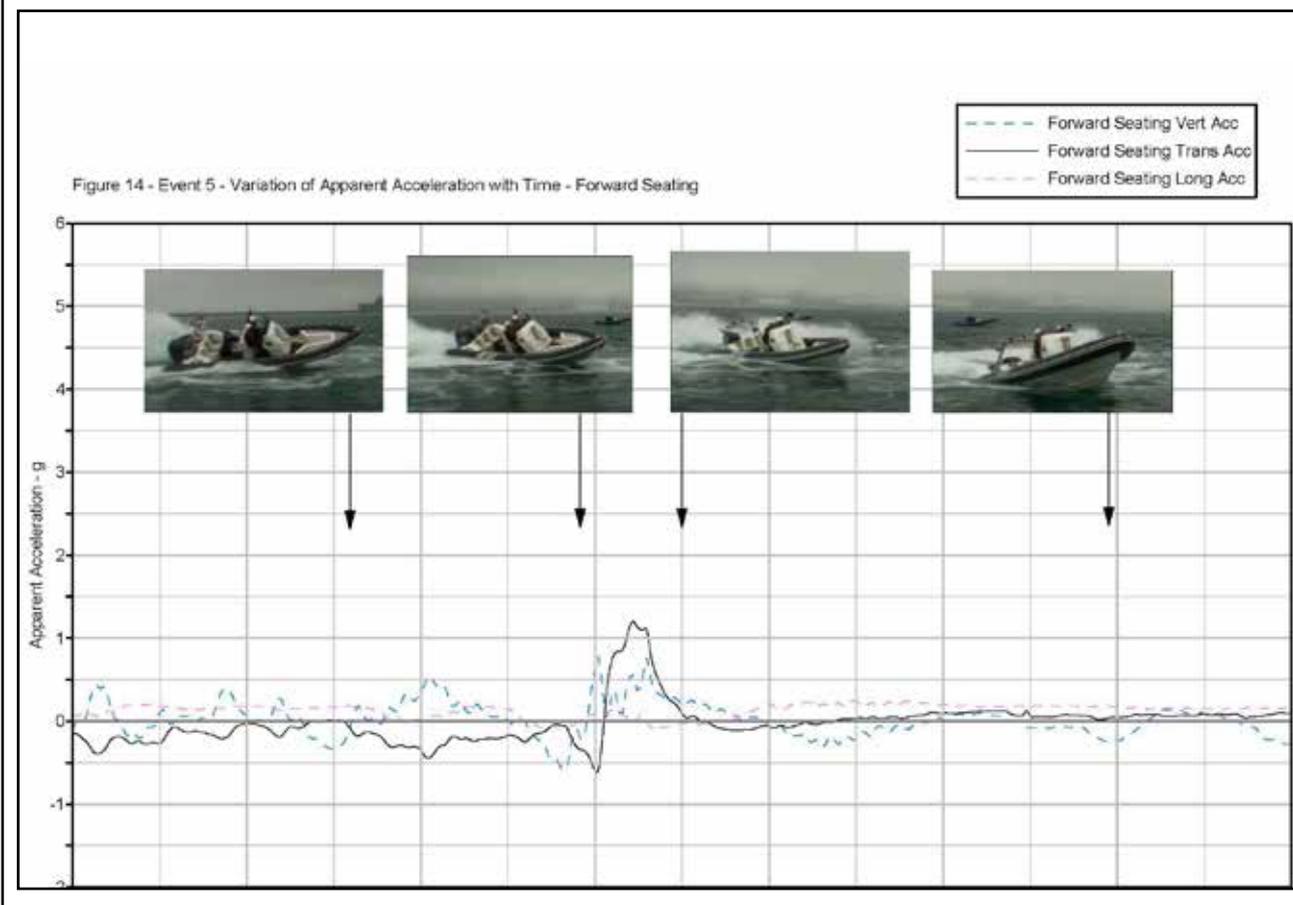
Figure 10: Graphs showing acceleration data obtained during trials

The trials conducted on *Milly* provided a reliable reconstruction of the performance of the boat immediately prior to the accident and indicated the forces acting on the occupants during high powered turns. The boat was observed to hook on several occasions, and transverse acceleration forces up to 1.3g were recorded at the forward seating area.

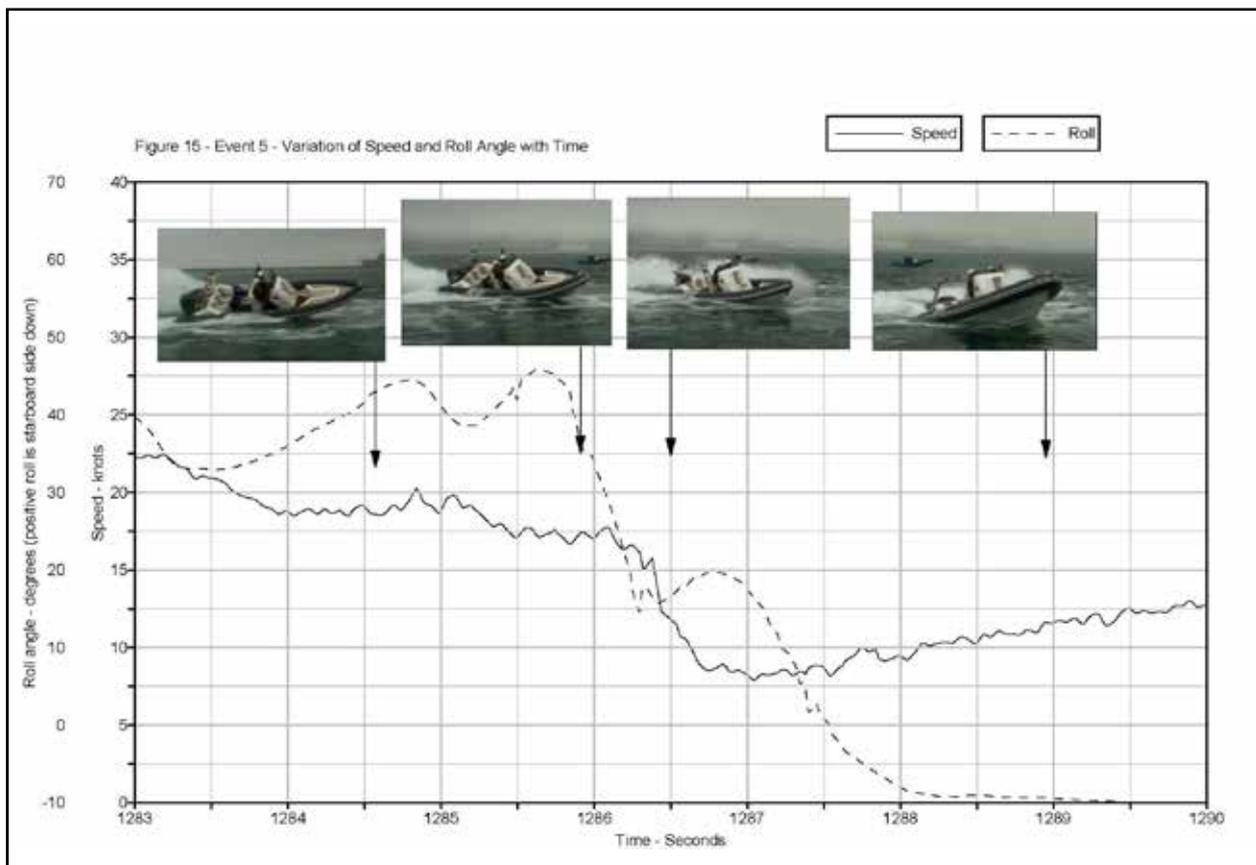
Figure 11: Graph showing change of roll angle against time

The highest transverse forces were experienced when the boat 'hooked' and then returned violently to the upright from heel angles of 40°. It was found on one turn that the boat had rolled 30° in less than half a second. The nature of the seating in the forward part of the RIB did not provide adequate security against sudden, violent motion. Further, the conservation of momentum experienced by the occupants

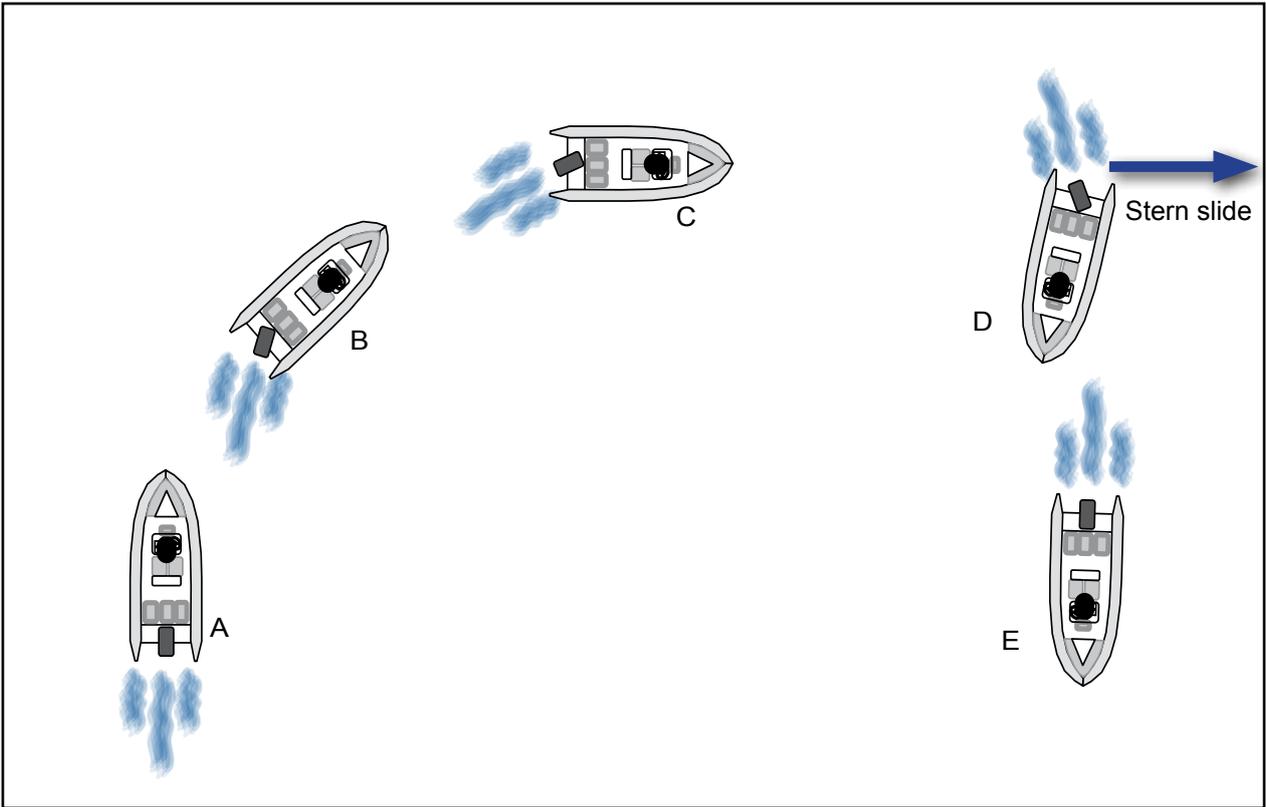
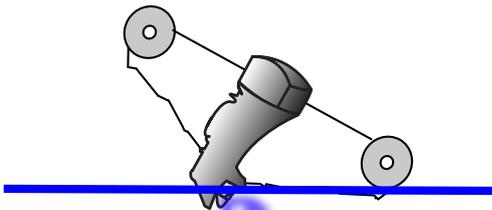
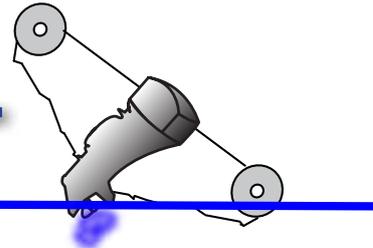
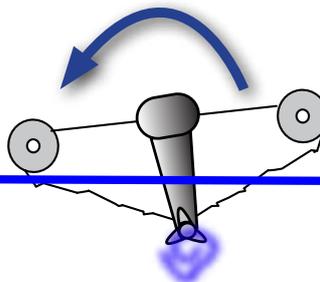
Figure 12: Diagram showing a hook during a turn

“When executing the turns, the craft initially would take up a high heel angle. It would proceed to turn, but if the speed was slightly higher than a particular threshold and the turn tighter than a certain degree, the heel angle would increase during the turn, and the aft end would lose grip and slide – thus initiating a ‘partial spin’ or ‘hook’ since the bow did not slide by the same amount.

This rapidly took the craft to a position which was appreciably diverted from its original course. The craft would execute a sideways slide and grip suddenly when it landed. Thus the hull’s sideways motion was suddenly stopped. Also, since the sudden grip was applied at the keel, the craft would violently roll upright from its banked attitude. It was noted that on these occasions the engine rpm would increase dramatically, indicating that the heel was so great, the propeller was losing grip on the water” (Figure 12).

The historic engine data obtained after the accident shows that the throttle was increased to full power which, with the helm to starboard and the engine slightly trimmed in, caused the boat to accelerate and turn quickly before hooking. It was this hooking action that resulted in the ejection of all the boat's occupants.

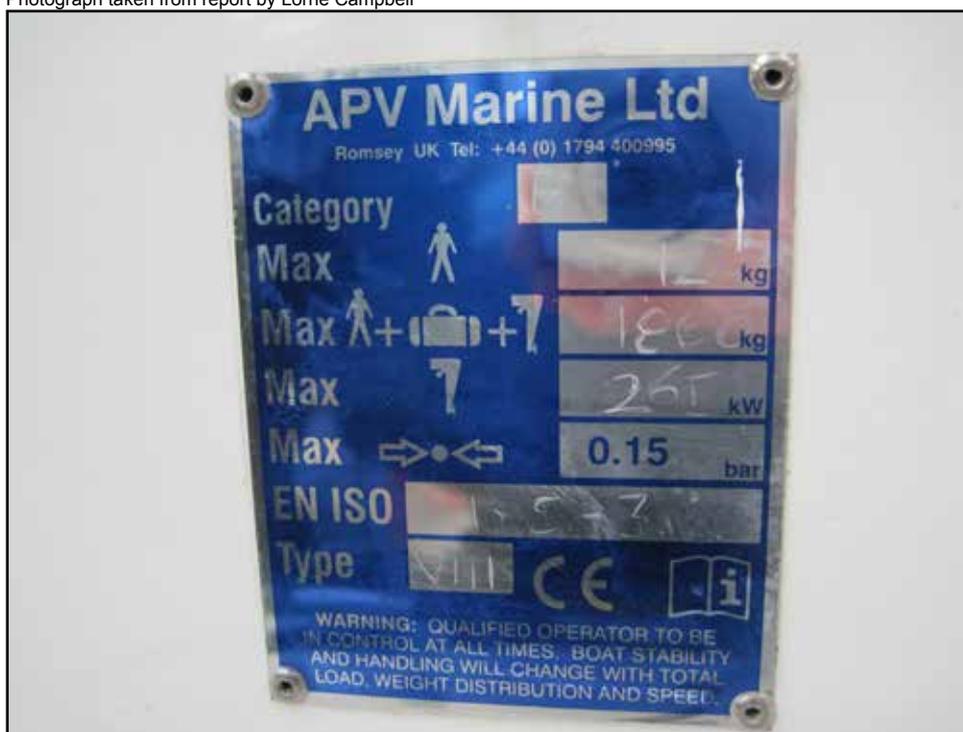
Figure 13: *Milly* - builder's plate

The CE-mark was displayed on *Milly's* builder's plate (**Figure 13**) together with references to the harmonised International Standards Organization's (ISO) standard used for its construction, ISO 6185-3:2001.

In *Milly's* owner's manual it was noted that the maximum engine power given for the boat was 336kW (450hp), as opposed to 264kW (350hp) on the DoC. The maximum power was listed on the builder's plate as 261kW but was barely legible due to the poor standard of marking used on the plate. Use of the formula listed in ISO 6185-4, which was the reference used in the technical file, gave a maximum power figure of 226kW (303hp).

4. The inconsistencies found in the manufacturer's RCD conformity documentation should be rectified as soon as possible. [2.6]
