## Serious injury on board the yacht *LIQUID VORTEX* 28 May 2011

### SUMMARY

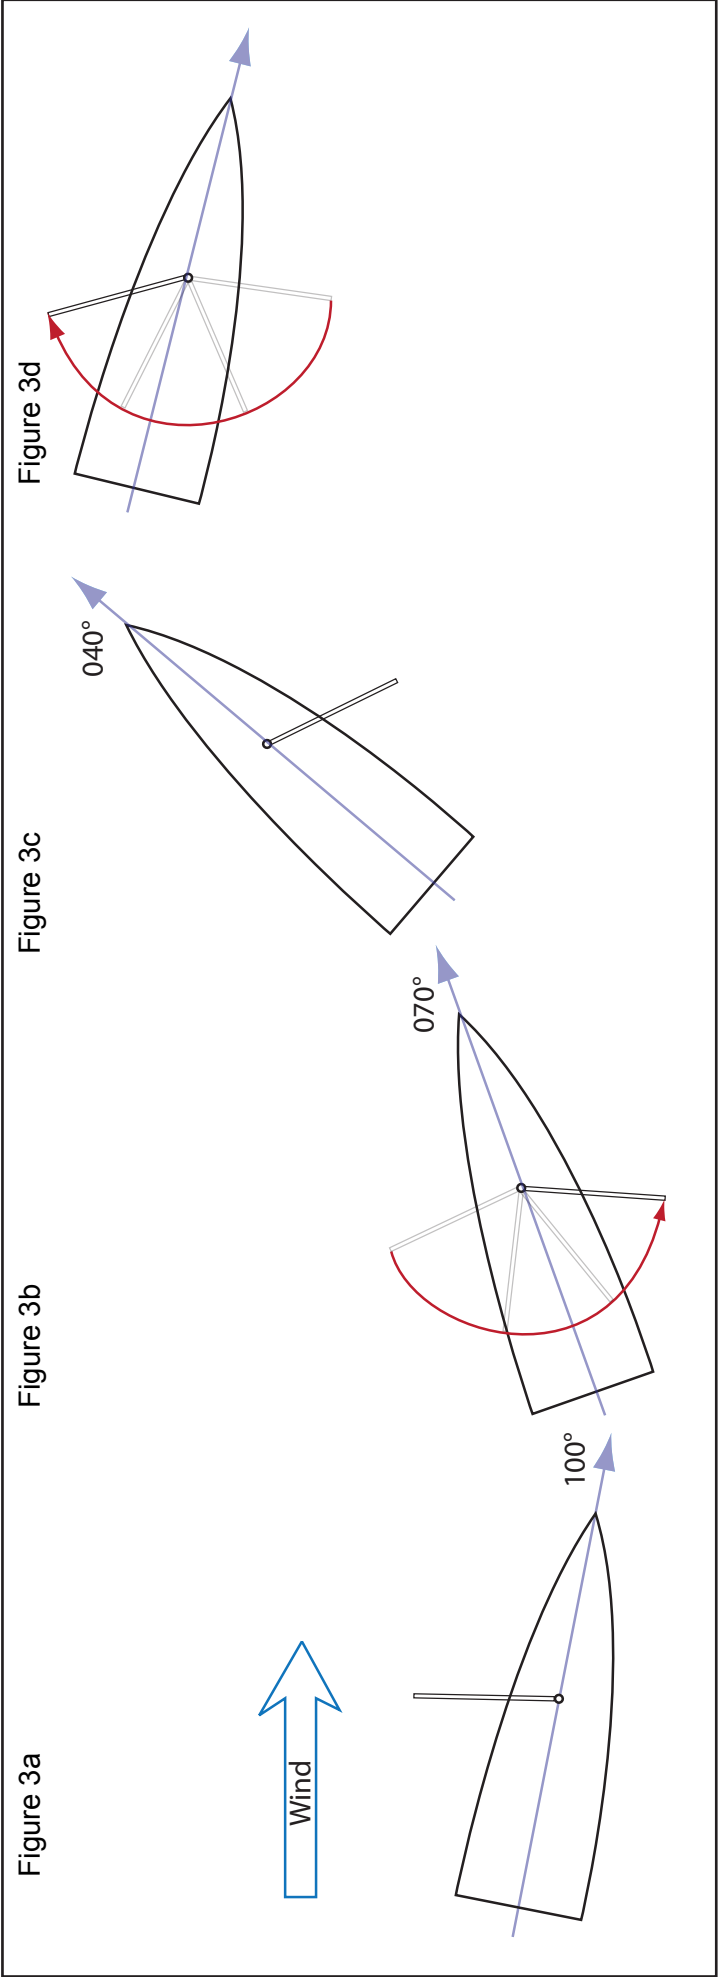
Figure 3

At about 0930, the yacht was sailing downwind, with the wind on the starboard quarter and the mainsail out to port (**Figure 3a**) when her spinnaker suffered a major tear.

The skipper took the helm and ordered the mate to replace the torn sail with a smaller but heavier spinnaker. He then deliberately gybed the yacht onto a heading of about 070° to put the mainsail on the starboard side (**Figure 3b**). The mate and two of the crew went onto the foredeck, lowered the damaged sail and began to hoist the heavier spinnaker. As they did so, the spinnaker became wrapped around the forestay.

He handed the helm to the nearest member of the crew, a 23 year old female, and told her to "*alter course to 040°*". The helmswoman complied and brought the yacht's heading towards 040° (**Figure 3c**). The helmswoman had steered the yacht the previous day but this was the first occasion during the race that she had steered the vessel when running downwind. Before the skipper left the cockpit, he noticed a fishing vessel on a westerly heading off the yacht's starboard bow, but he did not consider that it would present a hazard.

The helmswoman was uncertain about the skipper's instructions. She put the helm to starboard and, without warning, the yacht gybed, causing the boom, mainsail and between 5m and 6m of the mainsheet to swing rapidly across the cockpit from the starboard side to its port side (**Figure 3d**). The helmswoman was knocked to the cockpit deck (**Figure 4**). The crewman in the cockpit immediately took over the helm and the yacht was again gybed unintentionally.

Movement of the vessel and effect on boom position

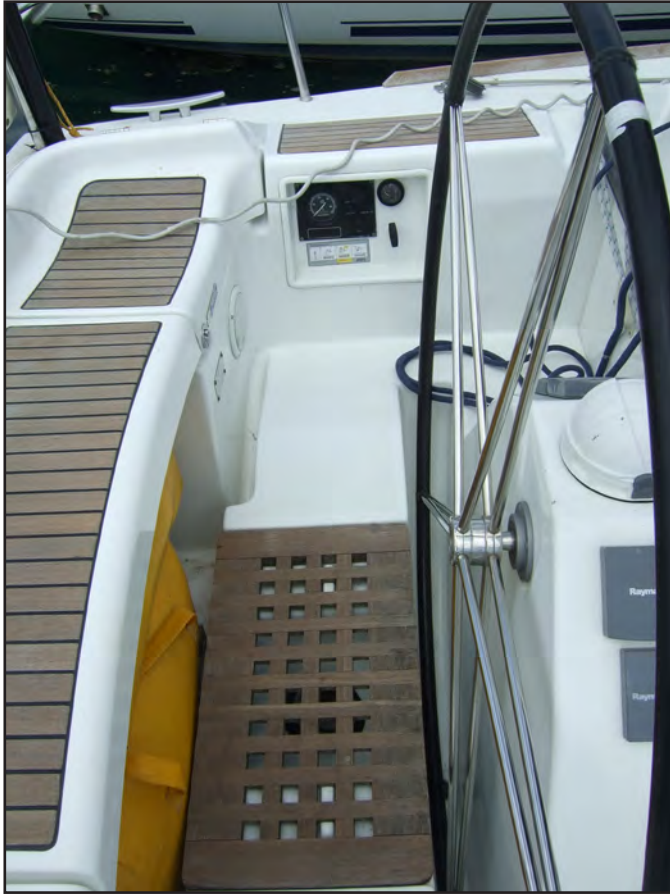
Figure 4

Cockpit deck behind the wheel where the helmswoman lay after the accident

several metres of slack line in the mainsheet to be thrown outwards (aft) towards her. The rope burns on the helmswoman indicate that the mainsheet caught her jaw and then knocked her to the deck as it tensioned when the boom swung out onto the port side. Her spinal injury was consistent with her head striking the side of the cockpit with significant force.

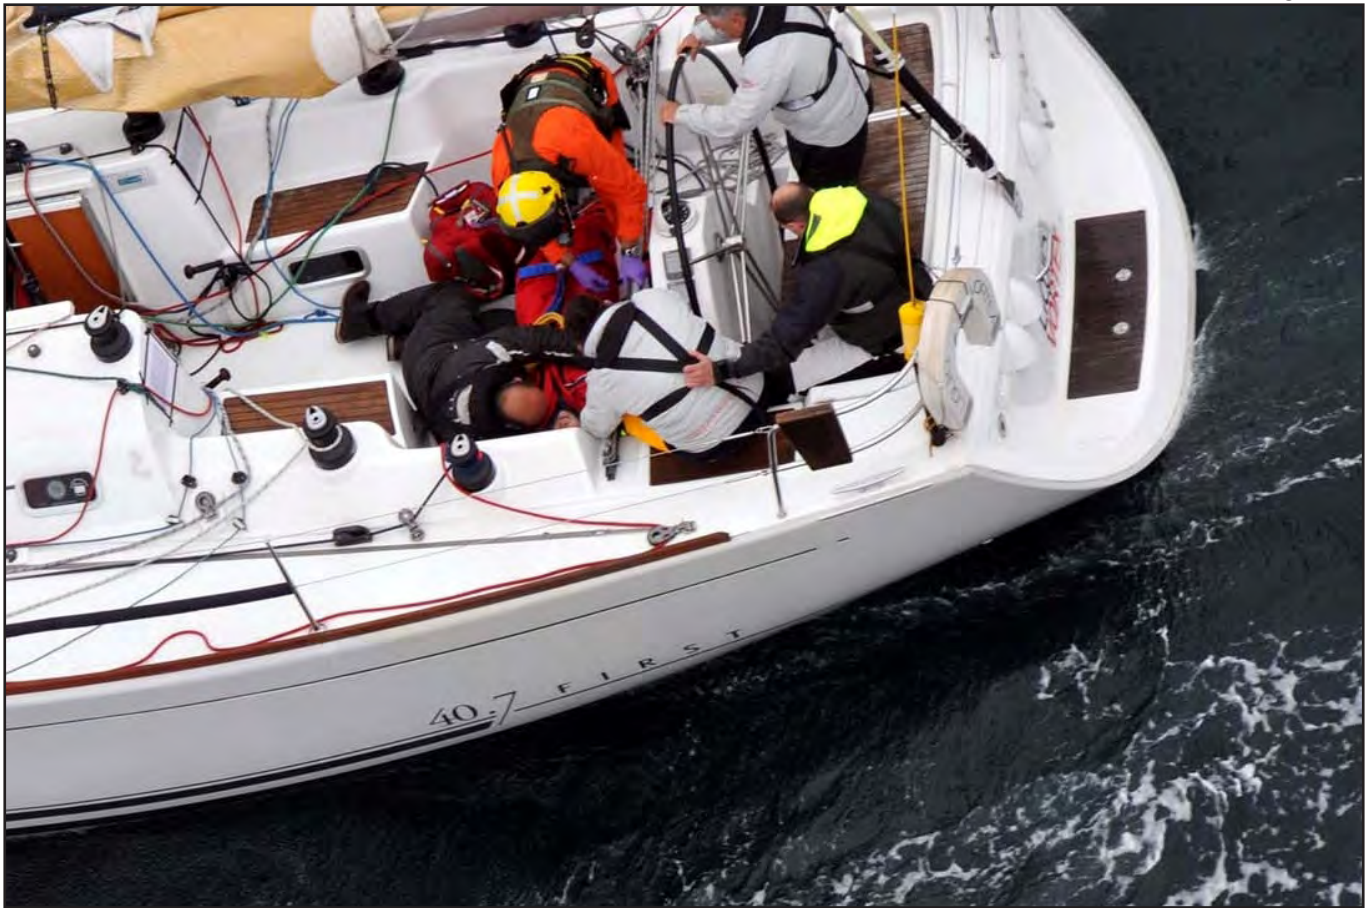
The “Mayday” call was heard by Brixham coastguard and, at 1019, a rescue helicopter was tasked to assist. It arrived on scene at 1047 and a winchman was lowered from the helicopter into *Liquid Vortex*’s cockpit (**Figure 5**). After an initial assessment, the helmswoman was then repositioned on the cockpit deck and examined by the winchman who was concerned that she might have sustained a neck or spinal injury. He was unable to fit her with a neck brace as her foul weather clothing was in the way, and instead used a rolled up towel to support her neck.

Winchman attending to helmswoman after she was repositioned in the cockpit

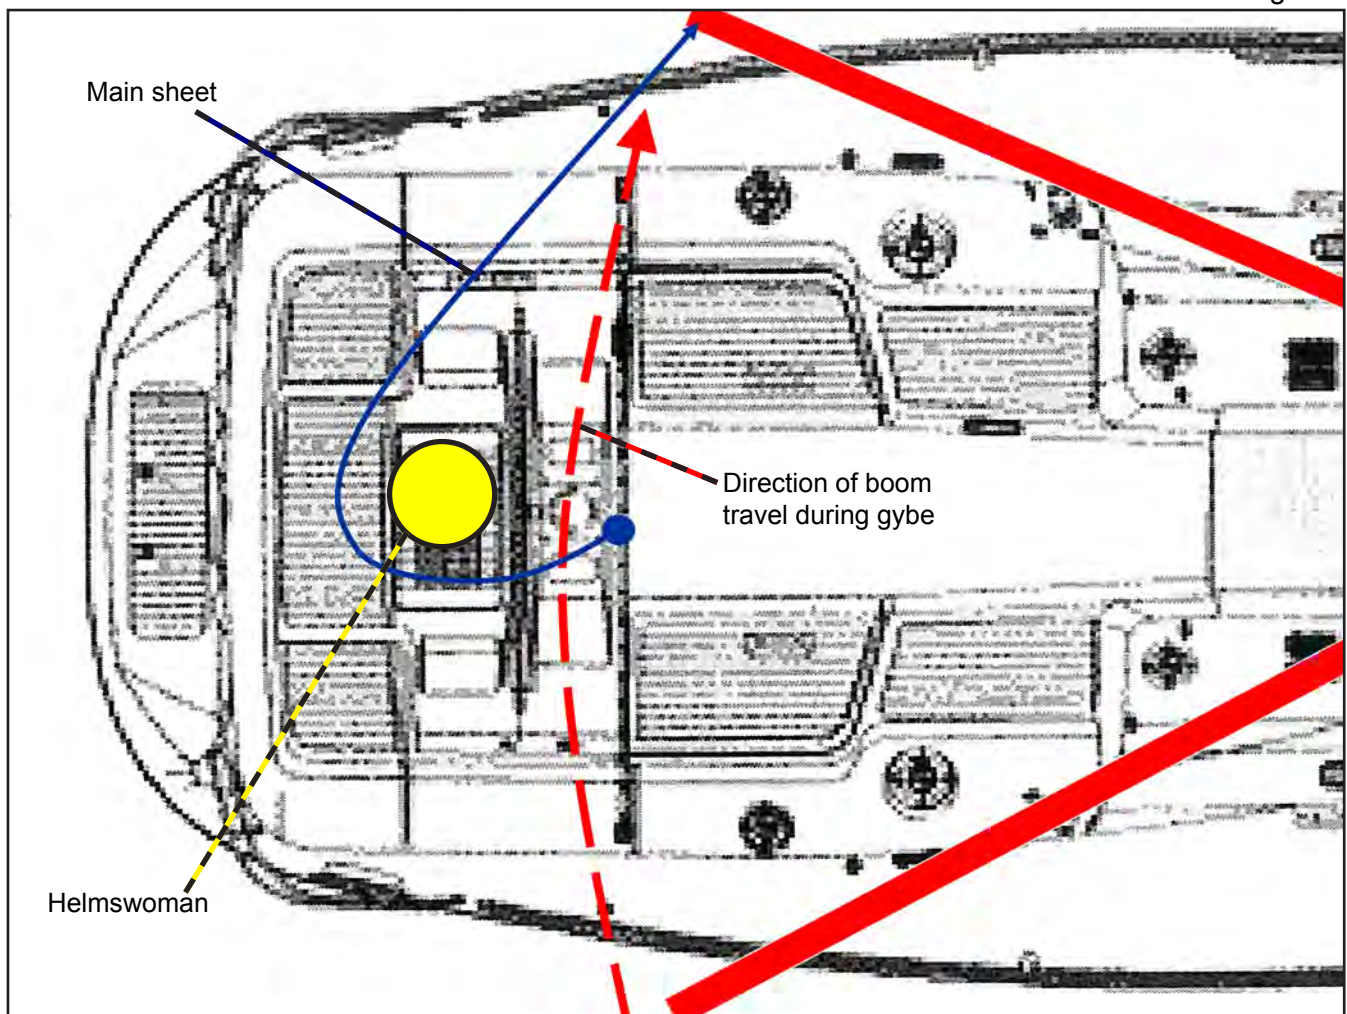
Figure 6

During the gybe, the mainsail, boom and mainsheet swung rapidly through about 140° from the starboard side to the port side. By design, the aft end of the boom was forward of the helm position (**Figure 6**) and would have swung in front of the helmswoman. However, the speed and force of the swinging boom would have caused

The MAIB is aware of numerous injuries resulting from persons being struck by booms, trimming blocks and mainsheets. However, this is the first serious accident the MAIB is aware of involving a helmsperson being struck by a mainsheet. It therefore highlights the potential dangers posed by all running rigging, not just the boom when a yacht is gybed both intentionally and accidentally.

Accidental gybe - movement of the boom and the mainsheet

2011/148 Establish a robust safety management system to ensure:

- The risks to its vessels and crews engaged in commercial operations are identified and thoroughly assessed
- Comprehensive operational procedures and guidance are developed to mitigate such risks
- Management oversight to ensure compliance with its procedures, once these are established.
