Report on the investigation of
the ejection of six people
from the rigid inflatable boat
Milly

Camel Estuary, Cornwall

on 5 May 2013

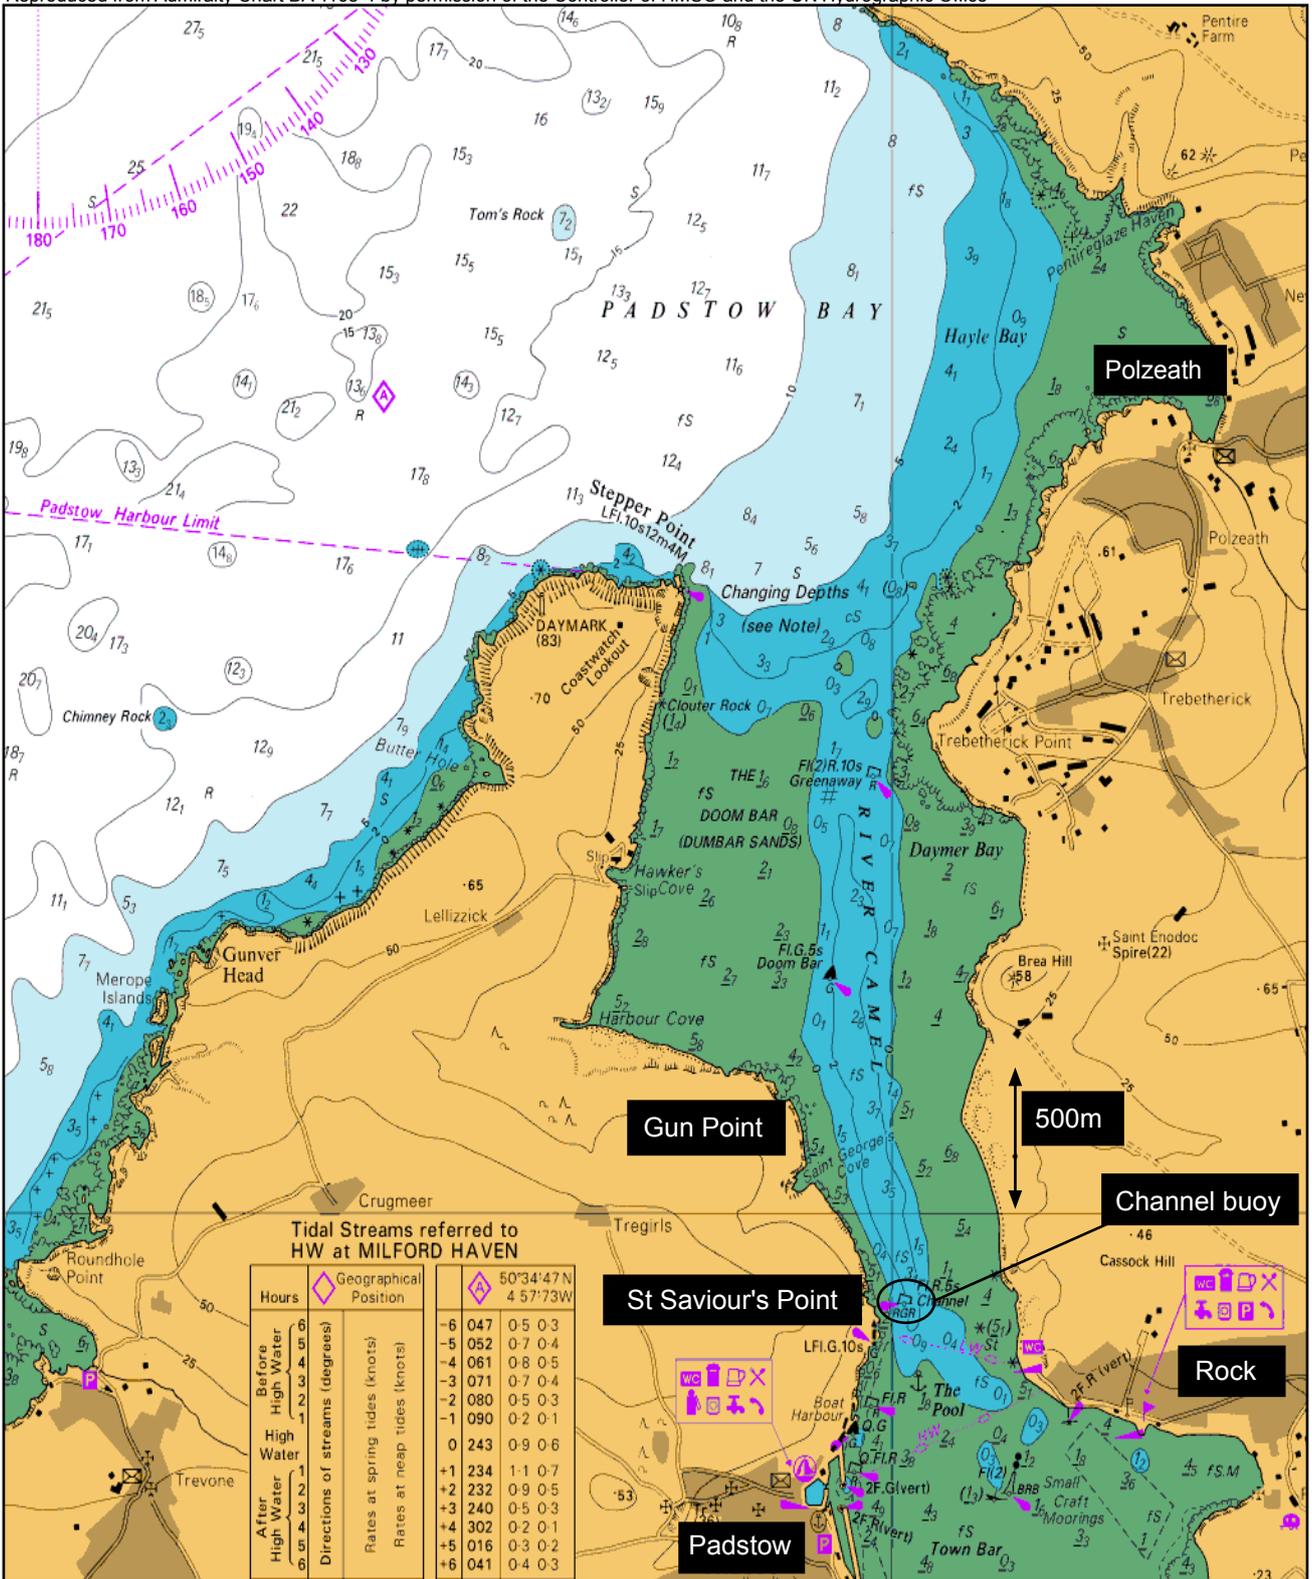
Figure 1: Camel Estuary showing area of the accident

At 1200 on 5 May 2013, 3 hours before high water, the family arrived at Rock to board *Milly* for a pleasure trip on the Camel Estuary (**Figure 1**). The family group, which consisted of Mr and Mrs Milligan and their four children, aged 4, 8, 11 and 12 years, all wore lifejackets or buoyancy aids when they set out from Rock at 1225.

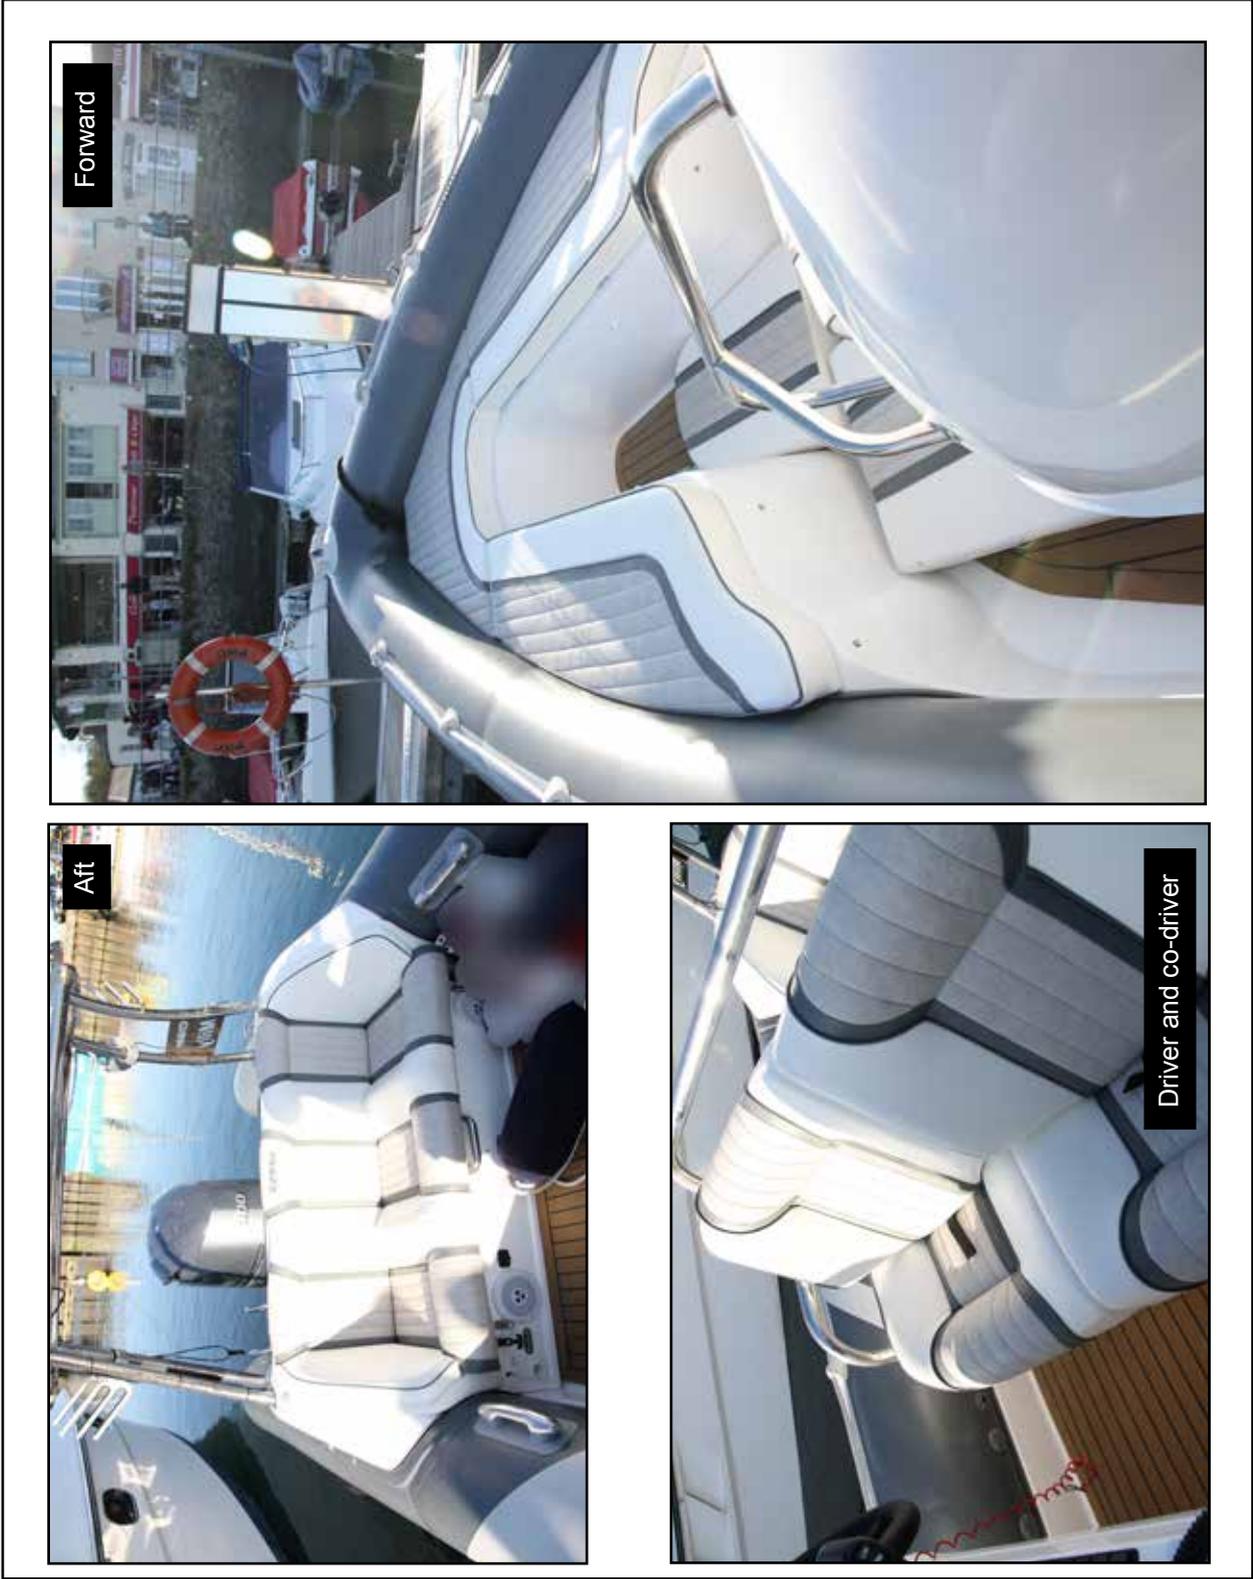
Figure 2: Milly seating arrangements

Milly was initially taken towards Polzeath and then returned to the estuary for a series of runs between Gun Point and St Saviour's Point. The runs consisted of oval circuits, which were conducted at speeds of about 30 knots (kts). Mr Milligan was driving the boat throughout this period and had the kill cord¹ attached to his leg. Mrs Milligan sat in the stern seats and the children were seated and standing in the forward part of the boat (**Figure 2**).

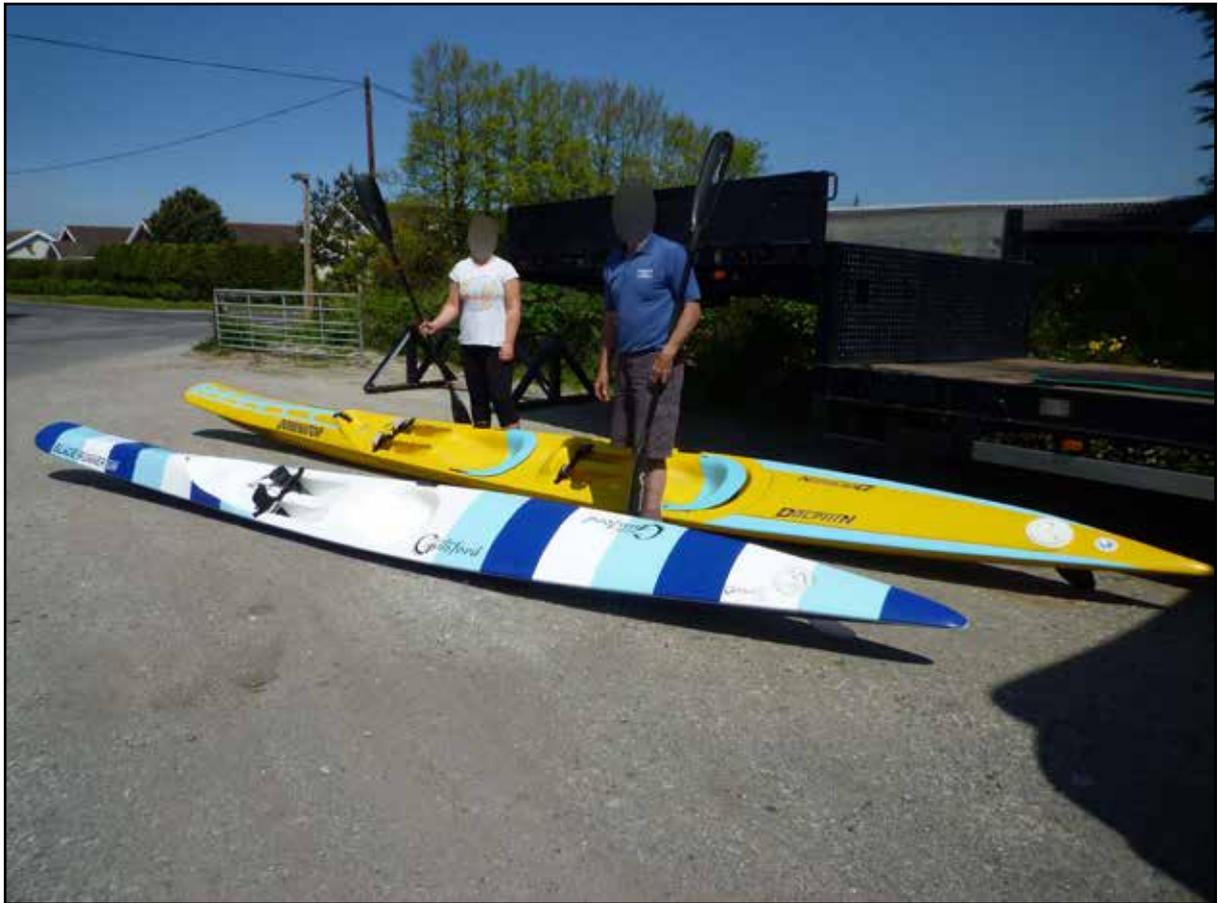
Figure 3: Canoes (Surf Ski Boats) first to arrive at the scene of the accident

At 1550 three canoeists who had witnessed the accident arrived at the scene. The canoeists were in two canoes, one single and one double (**Figure 3**), and at 1551 the single canoeist phoned the emergency services and reported the accident. One of the canoeists in the double canoe was a trained paramedic and immediately began to triage the survivors while her companion attempted to attract the attention of other boats in the area.

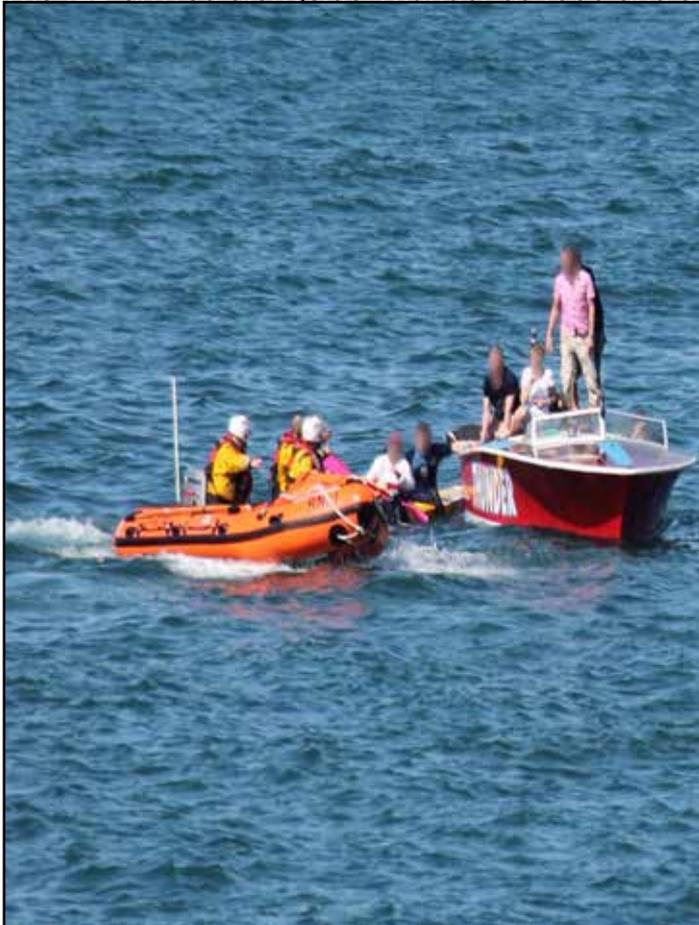
Figure 5: Rock ILB, *Thunder* and canoeists providing assistance

the water and off the double canoe onto the ILB and *Thunder* (**Figure 5**). The crew of the ILB decided that the casualties should be taken to Padstow harbour for medical attention and the ILB and *Thunder* headed towards the harbour.

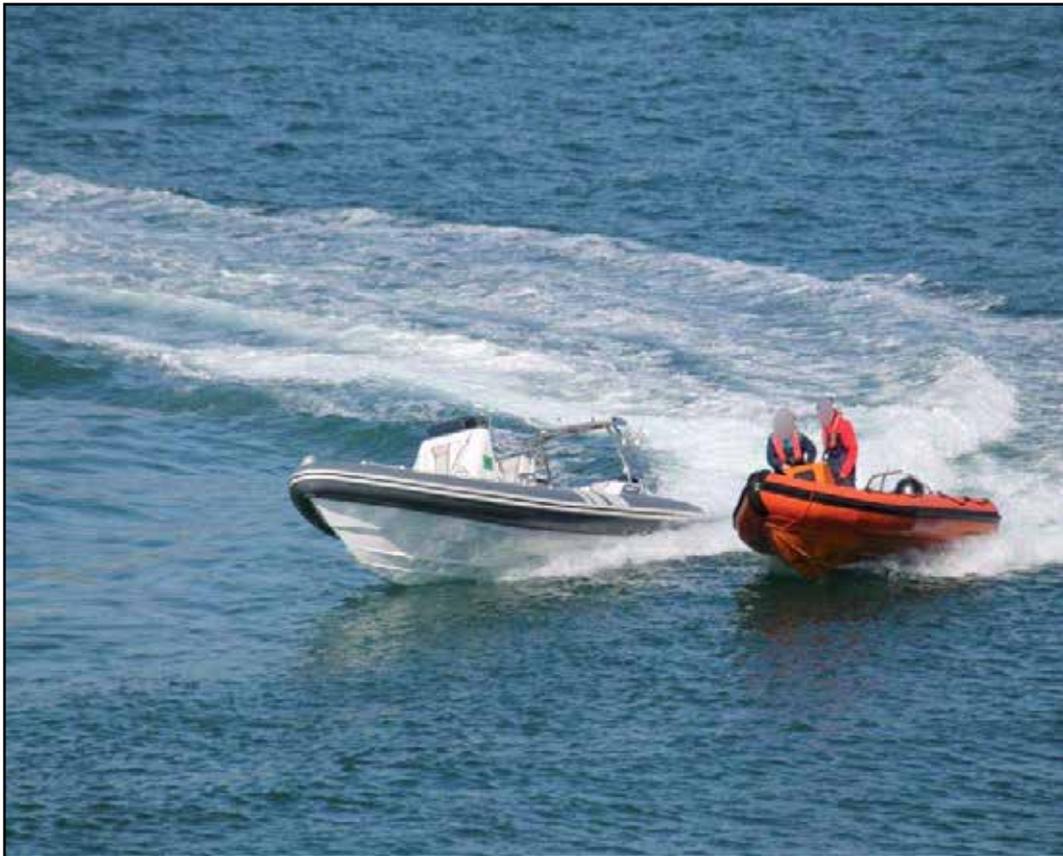
Figure 6: Local boatman about to board and regain control of *Milly*

At 1611 two local boatmen, in another RIB, had manoeuvred close to *Milly* and had thrown a rope into the water in an attempt to slow the boat down. When the other RIB got close enough, one of the boatmen was able to board and gain control of *Milly* (**Figure 6**).

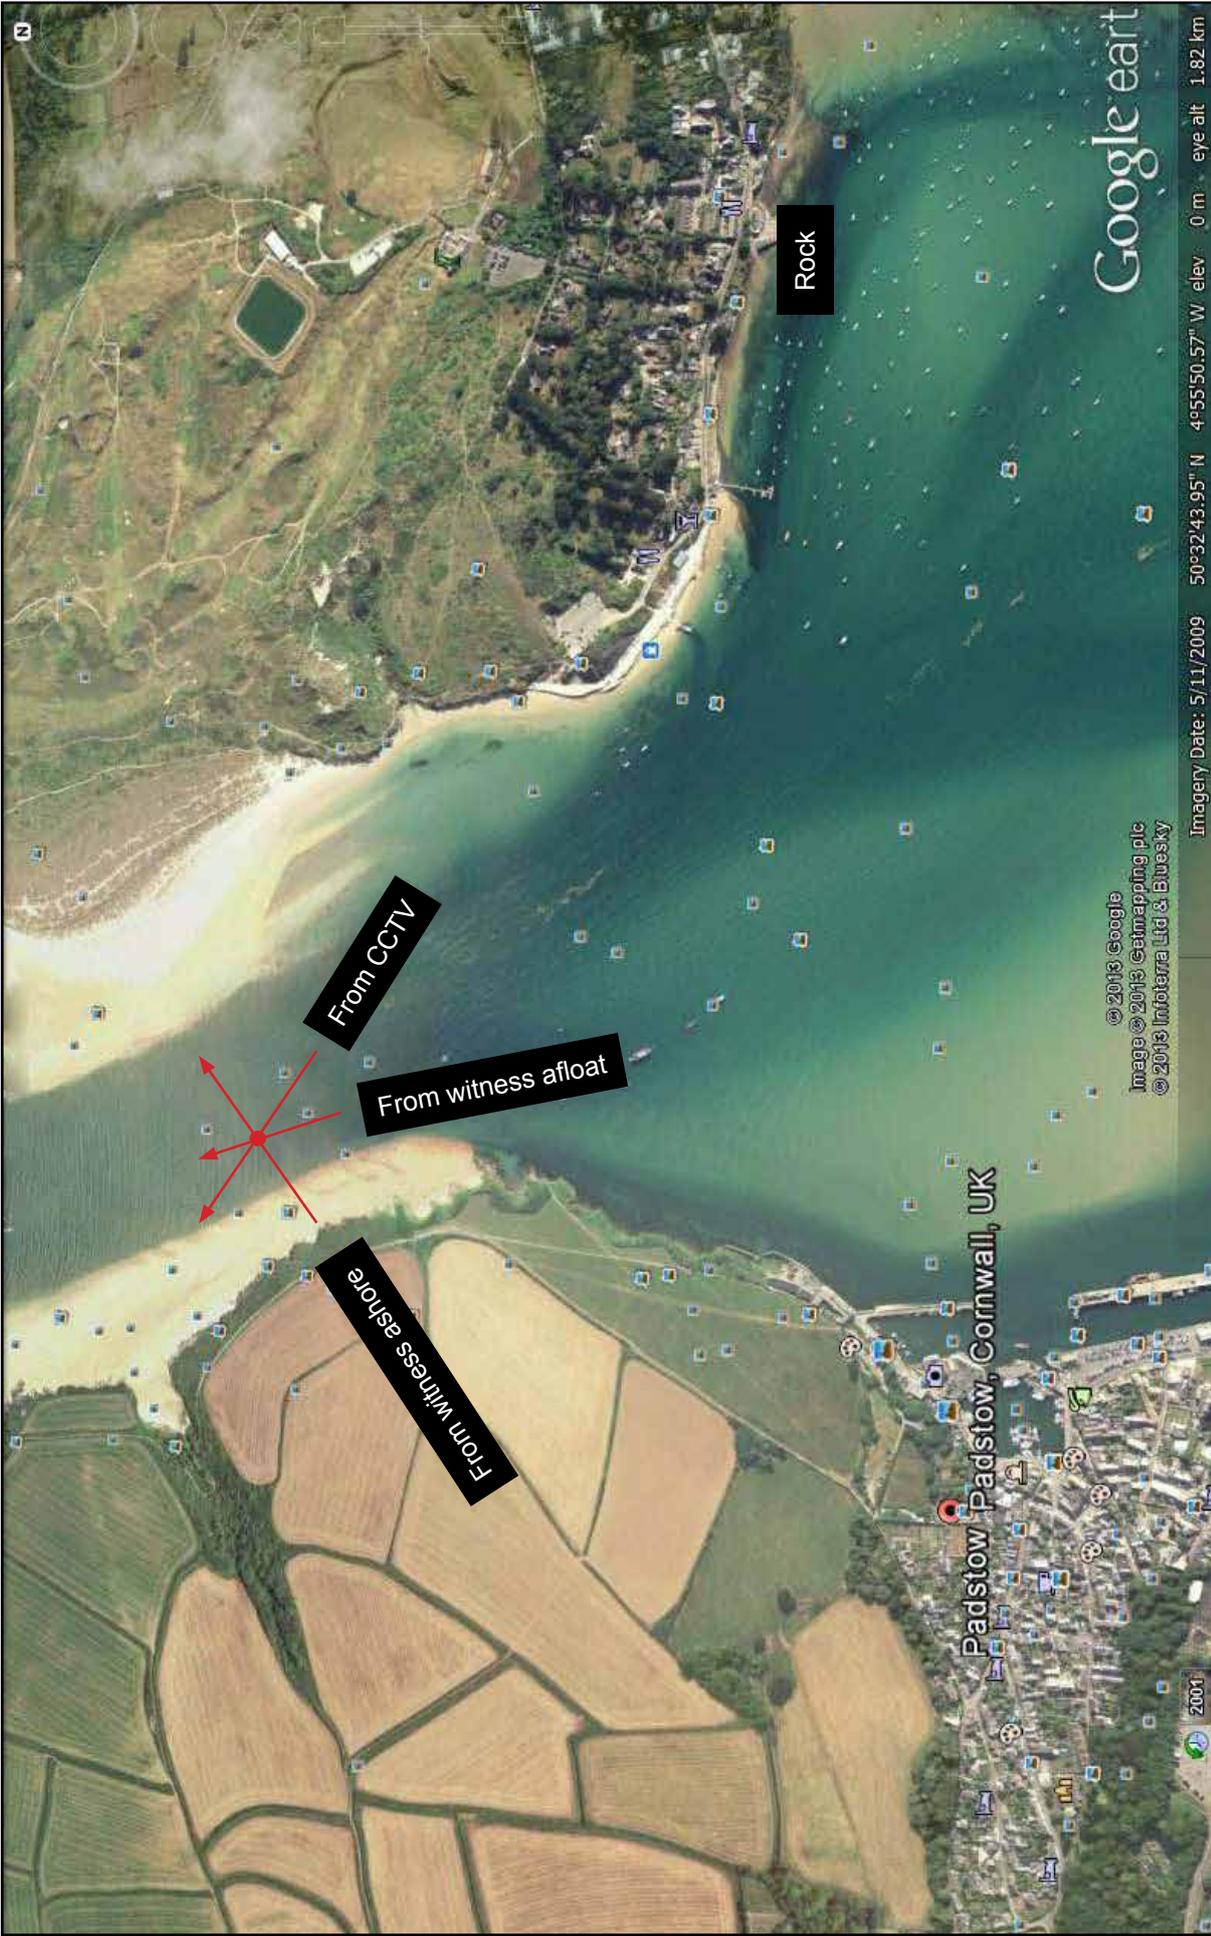
Figure 14: Triangulation of accident site based on photographic/CCTV evidence

The MAIB investigated the possibility that *Milly* had grounded during the turn to starboard that triggered the accident. A combination of evidence obtained from witness statements, photographs and closed circuit television made it possible to plot the position of the accident with a good degree of reliability (**Figure 14**).
